**THE MID-NET ZIPPER RIDGE A POSSIBLE
CAUSE OF UNOBSERVED PORPOISE MORTALITY**

David B. Holts

NOAA-TM-NMFS-SWFC-3

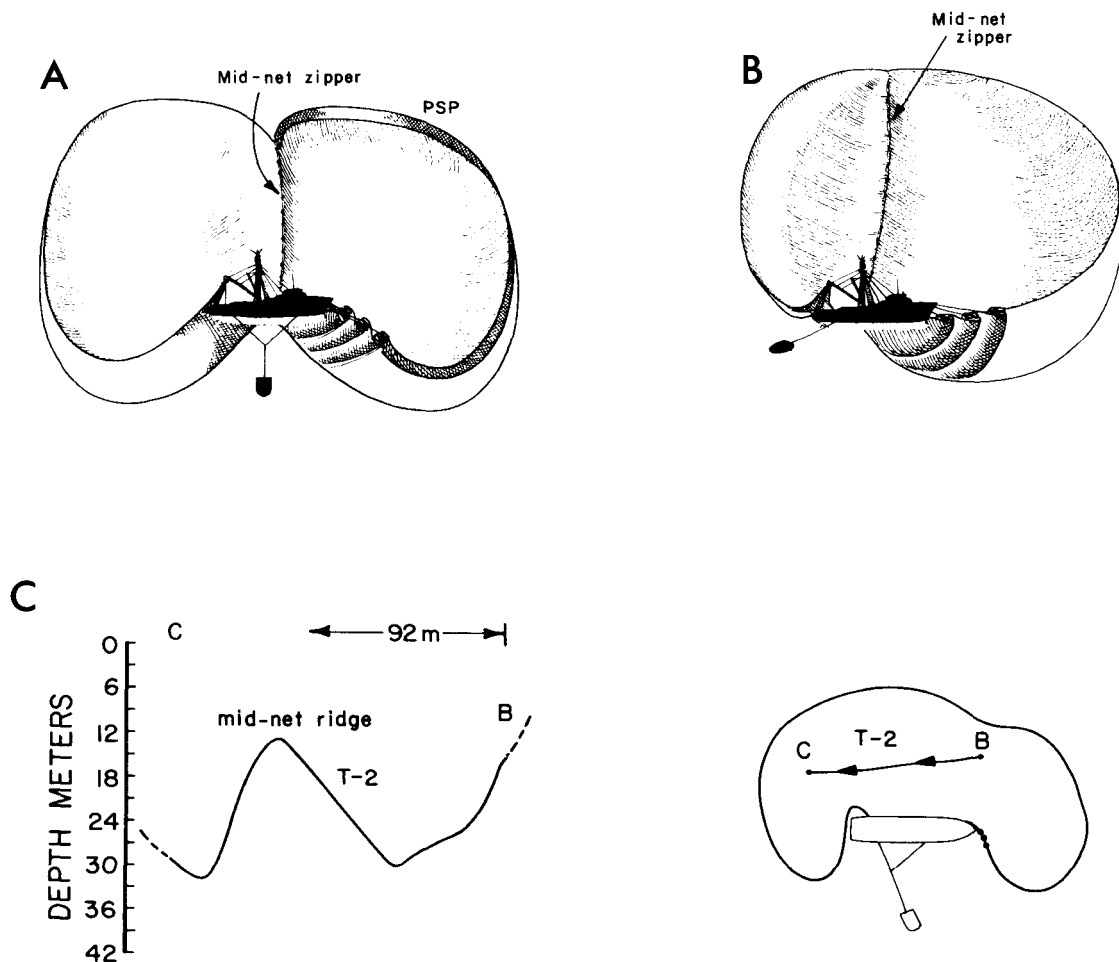
It has long been suspected that unobserved porpoise mortality occurs in deep areas of the seine prior to backdown. During the Dedicated Vessel Program¹, NMFS divers observed that the mid-net zipper² held up a wall of webbing 30 feet or more above the floor of the net (Fig. 1 A&B). The wall, or mid-net zipper ridge, formed during the pursing operation and persisted until it was rolled aboard. These observations were further documented by fathometer tracings collected from a small rubber raft crossing the net (Fig. 1,C).

Captured porpoise usually position themselves over the deepest area of the net. When large numbers of porpoise and tuna are captured, or when porpoise must cross over the zipper ridge, the probability of entanglement is greatly increased. NMFS divers have observed porpoise entangled in the overhanging wall of webbing and lesser folds associated with this area. The ridge has also been observed in a number of purse seines during local water hauls and has been noticeably absent in other seines.

The zipper ridge occurs when the stopper webbing is prevented from extending as far as the adjacent lighter web in the main body of the purse seine. A close look at zipper installation techniques has shown a definite advantage for those seines in which the stopper was installed with a greater amount of slack. While other factors may contribute to restrict full extension of the stopper, one fairly simple adjustment can eliminate them. This adjustment is most easily made at dockside but can be done at sea.

Another common cause of the mid-net zipper ridge is a short zipper line which restricts the full extension of the stopper webbing. This case is easily observed at rings up by noting if there is a greater tension on the zipper line than on the chains. Often an indentation of the corkline, at the zipper, protrudes into the net and towards the seiner (Fig. 1,A). This problem is easily corrected by splicing an appropriate length of line into the existing zipper line.

Figure 1. (A) Mid-net zipper ridge when fully pursed. Note indentation of corkline opposite vessel. (B) Zipper ridge with one-fourth net retrieved aboard vessel. (C) Fathometer trace when fully pursed.

The five inch mesh stopper must be re-hung to the 4 1/4-inch mesh with enough extra slack to permit full extension of the stopper. There are two accepted methods by which full extension can be achieved.

The first method is the simplest and the only one that should be attempted at sea. Here the existing five inch mesh stopper is cut out of the seine and re-hung, mesh-for-mesh to the 4 1/4-inch mesh. This provides approximately 30% slack in the stopper webbing. An additional one to three meshes of stopper web should be "killed-in"³ to each strip of the 4 1/4-inch mesh. For example, two fathoms of additional slack are provided when only two 5-inch meshes are killed-in for each strip of a 14-strip net. This procedure will ensure a problem free zipper line by providing for differential shrinkage rates between the five inch and 4 1/4-inch mesh, should it occur. Additionally, there is no loss of strength in this area since tensions remain uniform throughout these meshes.

The second method is the technique of stretching the five-inch stopper web evenly with the 4 1/4-inch mesh and tacking them together prior to lacing. This should only be done with pre-shrunk material and only on one side of the stopper at a time. Care must be taken to ensure that both sides are stretched equally tight prior to tacking. An additional three to five meshes of stopper web should be killed-in for each strip of 4 1/4-inch mesh to ensure enough slack in the stopper to prevent formation of the ridge.
