## VESSEL COLLISION WITH A LARGE WHALE OFF SOUTHERN CHILE

Robert L. Brownell, Jr.<sup>1</sup>, Barbara Galletti Vernazzani<sup>2</sup>, and Carole A. Carlson<sup>2</sup>

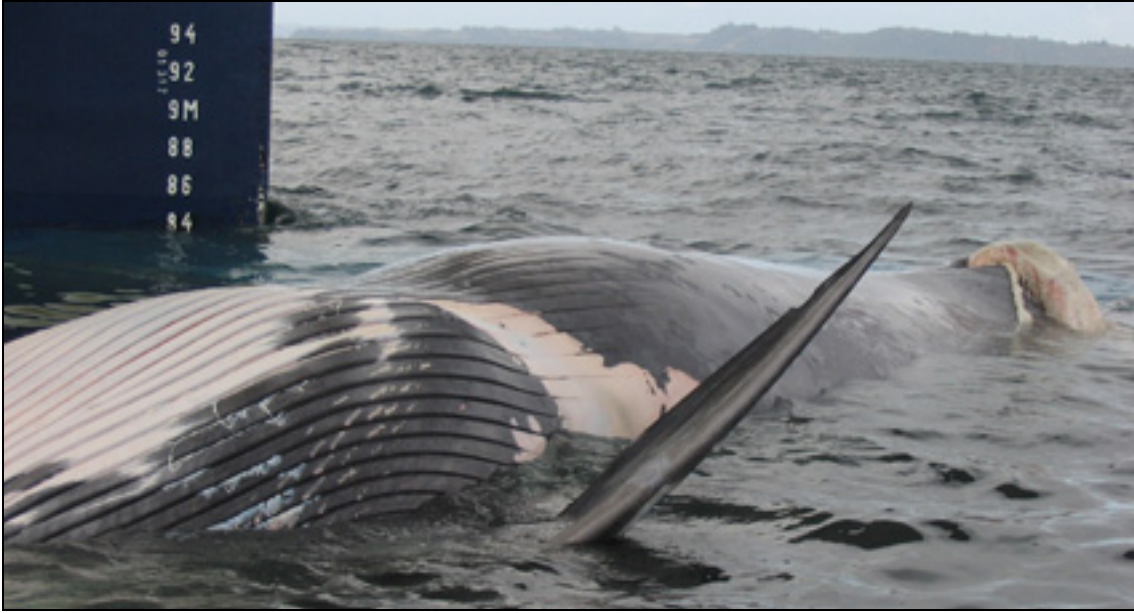
Figure 1. Puerto Montt sei whale discovered on bow of vessel on 29 January 2009. The species identification is based on the ventral coloration and specifically the characteristic irregular white coloration of the throat region.

Based on the photographs from the Gobernacion Maritima, we identified the animal as a female sei whale (*Balaenoptera borealis*) and estimated its total length at *ca.* 13.7 m (Figure 1). The species identification is based on the ventral coloration and specifically the characteristic irregular white coloration of the throat region. Also, the number of ventral grooves appears to be in the range for sei whales (32-60), rather than the 55 to 88 for blue whales and the 56 to 100 for fin whales (Geraci and Lounsbury 2005). In Figure 2, we counted 17 ventral pleats on the visible part of the right half from the approximate midline to the level of the anterior insertion of the flipper. From this we estimated the half count to be 24 for a total of approximately 48 grooves.

We estimated the total length of the whale by measuring the distance between the anterior insertion of the flipper and the genital opening. We measured this distance as 6 m by using the water line depths on the bow of the *Radiance*. Based on a stranded female sei whale with a total length of 15.3 m from near Concepcion, Chile on 5 October 2003 [see details on this whale below], the length between the anterior insertion of the flipper and the genital opening is about 43.8 % of the total length.

The tissue extending from the genital groove is not the penis as its diameter is greater at the distal end than at the base (Figure 1). The tissue in the various photographs appears too large and massive to be intestine. This tissue mass is most likely the distal end of the uterus. Therefore, we believe the specimen is a female.

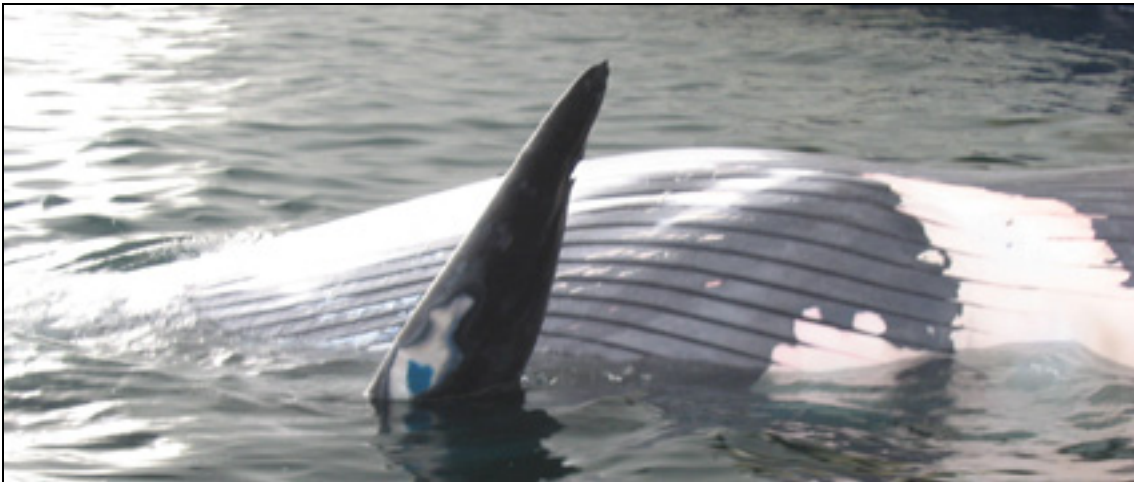
Figure 2. Ventral pleats of the Puerto Montt sei whale. We counted 17 ventral pleats on the visible part of the right half from the approximate midline to the level of the anterior insertion of the flipper.

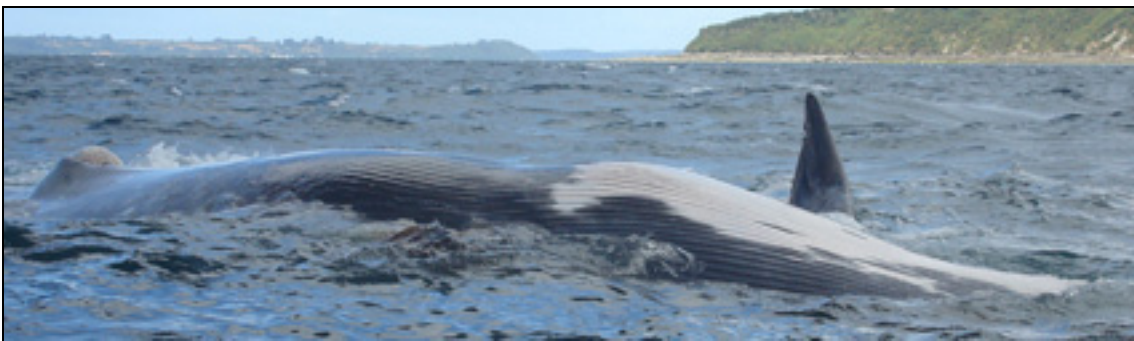
Figure 3. Puerto Montt sei whale showing the contact or strike area on the left side of the carcass.

Figure 3 shows the contact or strike area on the left side of the whale. Figure 4 shows a cut on the left lateral side of this whale. Figure 5 shows the contact area on the right side of the whale where the flipper and ventral grooves were rubbing on the skin of the whale after the initial impact. The right side of the whale was in contact with the bulbous bow below the surface of the water. This lower section of the vessel was painted blue.

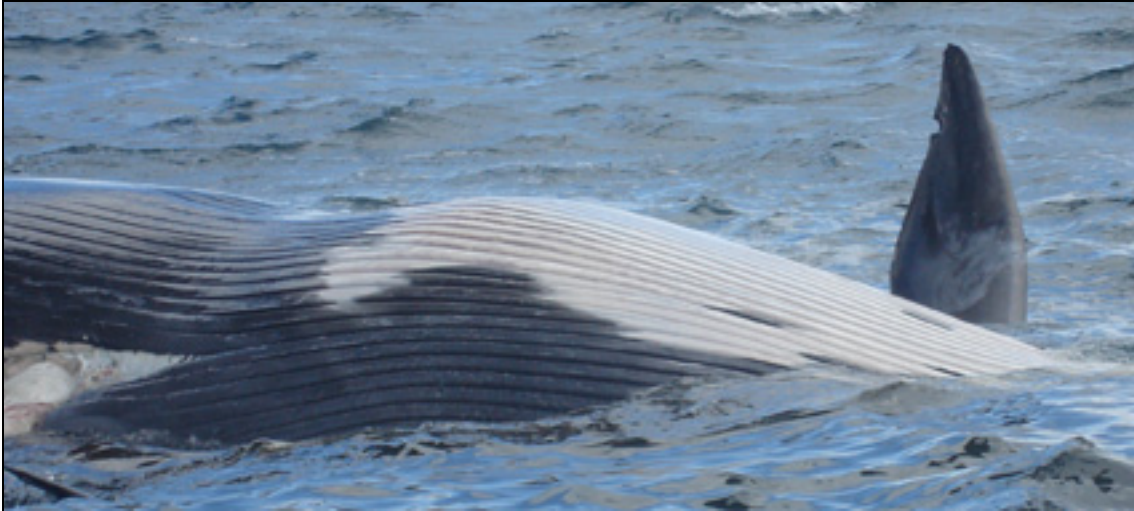
Figure 4. Puerto Montt sei whale showing cut on left lateral side.

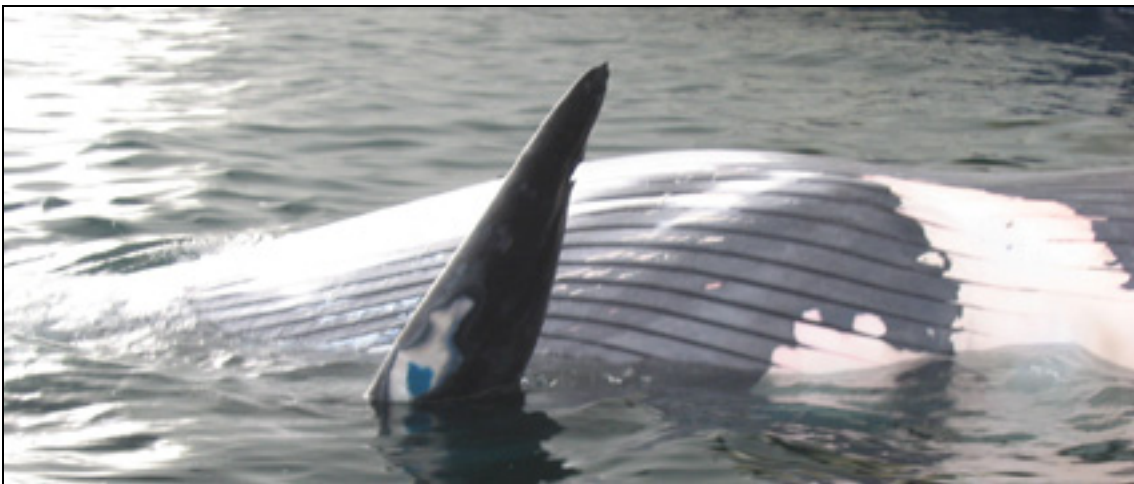
Figure 5. Puerto Montt sei whale showing blue paint on right flipper.

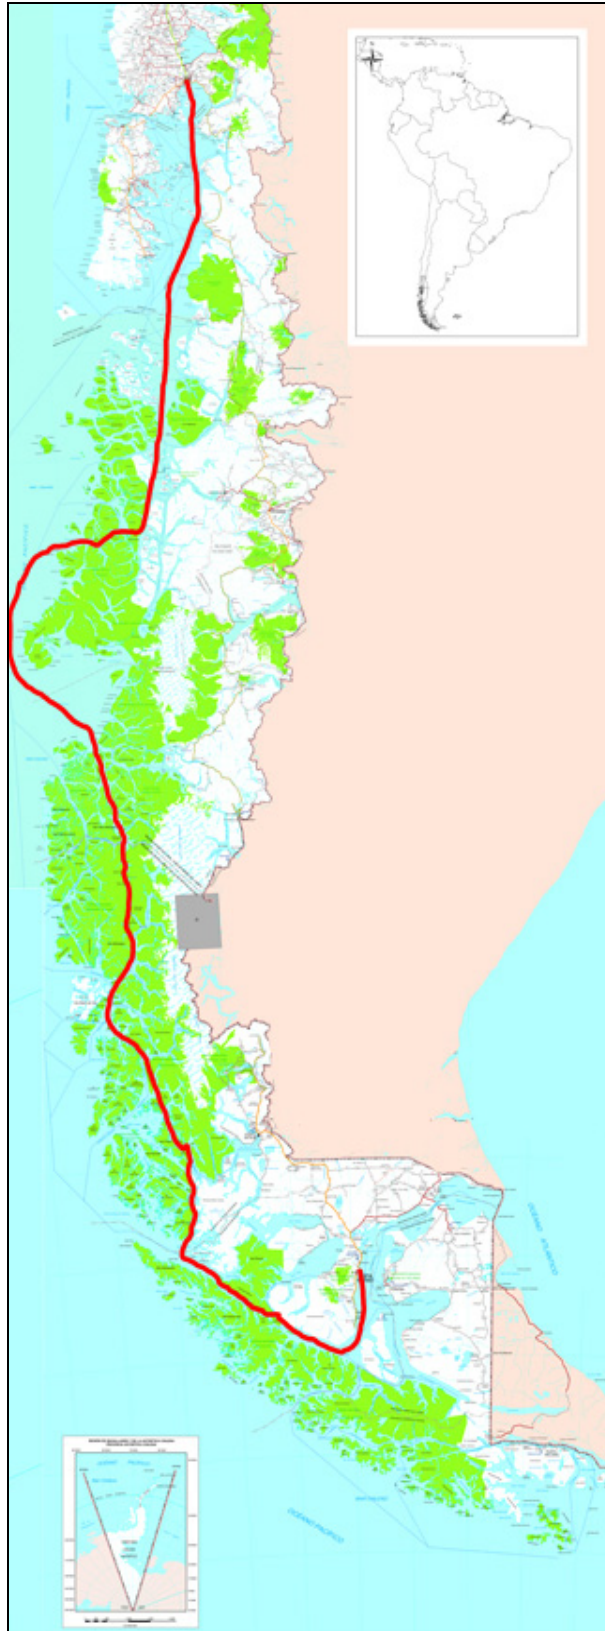
Figure 6. General route taken by cruise ships along the southern coast of Chile provided by the DIRECTEMAR.

According to the Direccion General del Territorio Maritimo y de Marina Mercante (DIRECTEMAR) from the Chilean Navy, the general route used by cruise ships in the coastal waters of southern Chile is shown in Figure 6. The waters in the Golfo de Penas regions are generally rough and therefore if a vessel transited this region with a dead whale on its bow the carcass would probably become dislodged. Therefore, we believe it most likely that the *Radiance* struck the sei whale after departing the Golfo de Penas.
